Idaho Nonpoint Source Program

2003 Field Evaluation Progress Report

Idaho Department of Environmental Quality

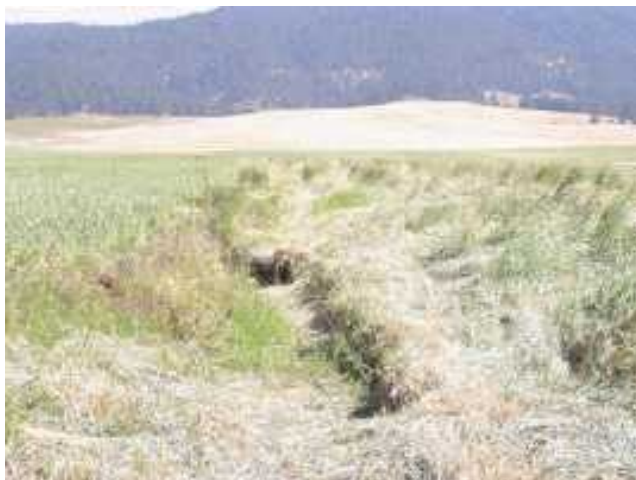
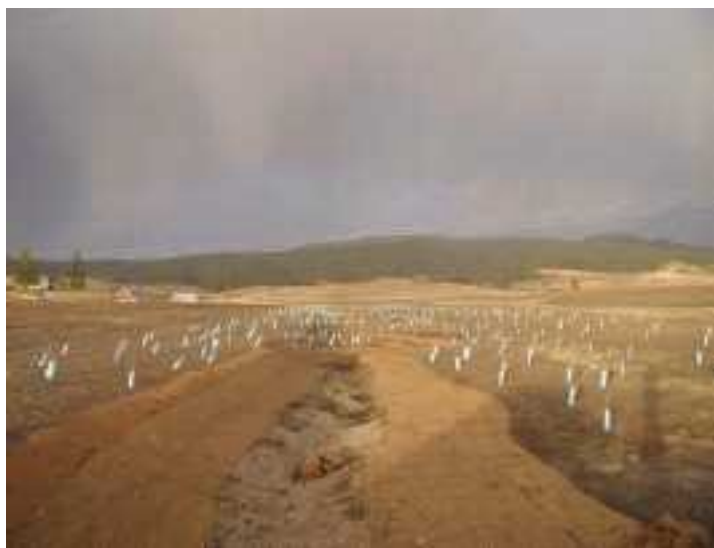
Previous Conditions: Due to agricultural development, the stream was braided into several small channels with steep, eroding banks in many places. The site was cultivated to the edge of the stream channel and no riparian vegetation existed. Reed canary grass lined the 40 foot wide braided channel. Our goals were to improve the water quality of the two tributaries that flow through the Townsend property, to increase diversity of native riparian vegetation, and to create habitat for wildlife. Water quality improvements focus on nonpoint source pollutants like temperature, sediment, nutrients and bacteria. Improvements at this site will contribute to improving water quality in the mainstem of Paradise Creek.

Figure 75: Townsend Waterway prior to reclamation

Figure 76: Within one year Townsend waterway will have stable banks and support sustainable, healthy riparian vegetation.

Description of Completed Activity: The scope of work included excavating the floodplain, defining a narrow, low flow channel and planting a riparian buffer of woody and herbaceous species. Excavation occurred in September 2003. Excavation was done in two phases. The downstream end, below the confluence of two tributaries was completed first and excavation of the eastern-most tributary was second. The channel was constructed using an excavator and excess soil was spread outside the floodplain on the Townsend property using a bulldozer. A multi-level floodplain was constructed to accommodate varying flow levels. Meanders were constructed in the new stream channel. A two layered soil wrap revetment was constructed on the downstream end of the project to protect against further erosion of a previously existing scour pool. After construction, all exposed soil was seeded with native grasses and banks were covered with erosion control fabric. In October and November 2003, a riparian buffer of native trees and shrub, varying in width from 45 to 90 feet, was planted on either side of the stream (Figure 75 and Figure 76).

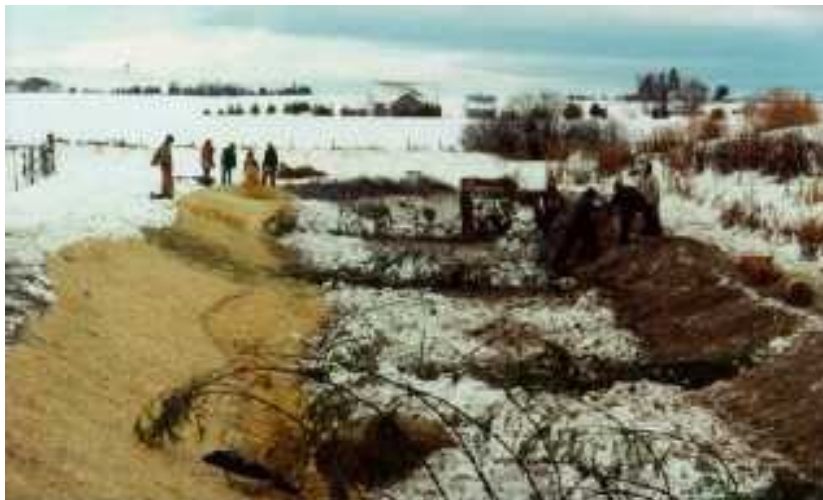
Previous Conditions: Stream banks along this tributary to Paradise Creek were eroding due to a lack of woody vegetation and steep banks. Reed canary grass formed a dense monoculture, whose shallow root mats did not prevent slumping of the stream bank. Thus, stream banks were frequently undercut during heavy storm events. The lack of trees or woody vegetation along this stream segment allowed direct solar radiation to heat

the stream water. There were also high levels of sediments in this tributary that added to the sediment loads of Paradise Creek.

Figure 77: Biologs® stabilize stream bank

Description of Completed Activity: The main purpose of this project was to create a sediment catchment system to trap sediment-filled high water. Another goal was to stabilize and revegetate a 300-foot section of the tributary to provide habitat for wildlife, provide shade to reduce stream temperatures, provide a vegetated buffer from agricultural runoff, and reduce the amounts of sediments entering the stream. Earth moving was completed by Professional Operators Company. PCEI staff and volunteers completed the bank stabilization activities. The catchment banks were sloped to a 3:1 slope. This moderate slope reduces erosion, reconnects the stream to its floodplain, and creates a prime area for native vegetation. The resloped banks were seeded with a riparian grass mixture and covered with geotextile fabric. Native woody vegetation was planted in the spring of 2002. All excavated material was removed off-site. In selected areas (Figure 77), coconut fiber-filled BioLogs®, pre-planted with wetland plants, were installed along the toe of the stream bank for stabilization and to improve water quality through the water-filtering qualities of wetland plants. Woody debris of cedar and pine were installed in the catchment to act as a filter and, in turn, to slow the velocity of the water so sediment could settle out. Planting of native woody and herbaceous vegetation was completed in the spring of 2002 by PCEI staff and volunteers.
